Help Sheet 1

RF Feedback

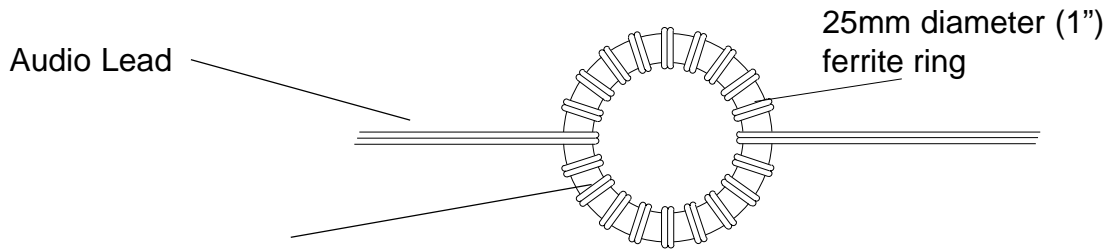
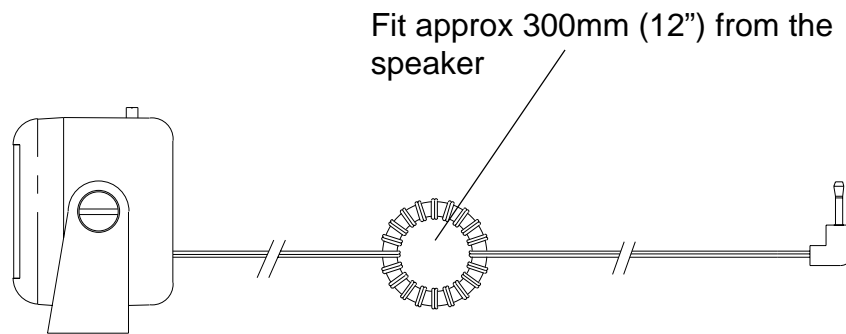
Figure 1.
Ferrite ring winding detail

All bhi products will operate correctly under normal working conditions. However if problems with feedback are experienced during transmission then the following help sheet has been prepared to help resolve this problem.

Wind as many turns as possible around the ferrite

Try transmitting again. If the problem persists , then move to step 2.
